## **PROBLEM IDENTIFICATION: Bethlehem Pike** **Springfield Township, Montgomery County, PA**

The intent of this memo is to document the major problems pertaining to traffic conditions that may warrant context sensitive solutions and/or calming measures along Bethlehem Pike in Springfield Township. The problems described here have been identified by local officials and substantiated through site visits and analysis by DVRPC staff.

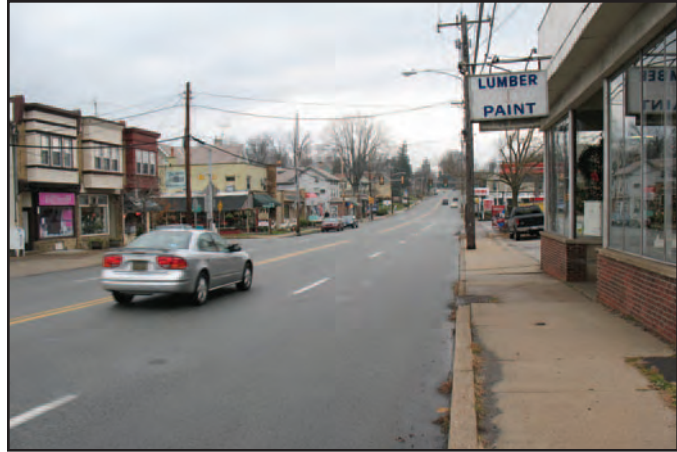
### 1. Excessive vehicle speeds northbound due to steep grade between Stenton Avenue and Gordon Lane.

The high-volume intersection of Stenton Avenue, Paper Mill Road, and Bethlehem Pike is located at the southern end of the study corridor. Vehicles proceeding north along the corridor encounter a steep grade, and at the northern end of the incline, a sharp curve. As identified by the steering committee, a significant number of drivers increase their speed on the grade, maneuver the curve at dangerous speeds, and accelerate again when the roadway geometry opens up into a straightaway. Moreover, this portion of the corridor is lined with street-edge businesses and residential streets, where high-speed traffic is inappropriate and presents safety concerns.

The straightaway past the curve at Gordon Lane (northbound) results in drivers accelerating just as they are entering a traditional business district where high speeds are inappropriate. (Photo: DVRPC)

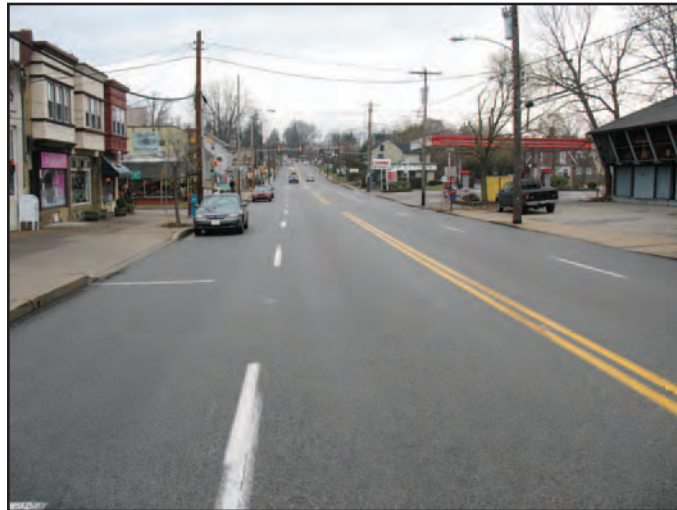
### 2. Potentially dangerous conditions created by Bethlehem Pike's inconsistent parking scheme

At several points along the corridor Bethlehem Pike is lined with traditional, street-edge businesses, some of which are served by on-street parking. Because a designated parking lane does not exist along Bethlehem Pike, this on-street parking is permitted in the travel lanes in certain sections of the corridor and during certain times of day (not during AM and PM peak periods). This presents a potentially hazardous situation as motorists traveling through the corridor encounter parked cars in the travel lane, and are forced to stop suddenly and merge into the adjacent free-flowing travel lane. One location of particular note is the section of Bethlehem Pike near Montgomery Avenue. There is a significant volume of southbound left-turning traffic at this location. However, vehicles are permitted to park in the right-hand travel lane. The combination of parked vehicles in the right lane and turning vehicles in the left lane creates a situation where traffic stacks in both lanes and seriously limits the capacity of Bethlehem Pike.

The need for on-street parking and the lack of dedicated parking lanes results in this unusual allowance of on-street parking in an active travel lane — a potentially dangerous condition. (Photo: DVRPC)

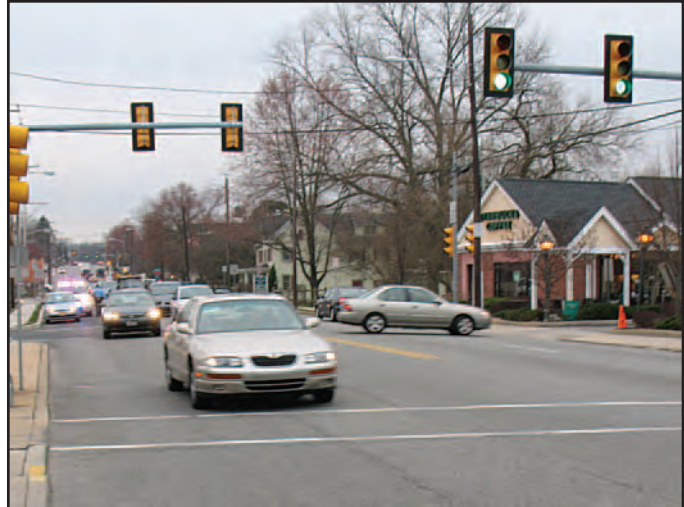
**3. Retail hub in the vicinity of Bysher Avenue experiences high volume of traffic and pedestrians, and has a demonstrated crash history.**

The steering committee and the study team have observed dangerous conditions for both motorists and pedestrians at the intersection of Bysher Avenue. This offset intersection has several elements that create potential conflicts with through traffic, turning vehicles, and/or pedestrians. The main issue centers around the access point for the Starbucks, located directly between the two legs of the offset intersection. This uncontrolled access point adds to an already confusing situation with through traffic moving at different signal phases, and compromised sight distance for turning traffic. Opposing left turns obscure visibility of through traffic, making left turns potentially dangerous.

The offset intersection coupled with the Starbucks access point creates a confusing intersection with poor sight lines, and a demonstrated crash history. (Photo: DVRPC)

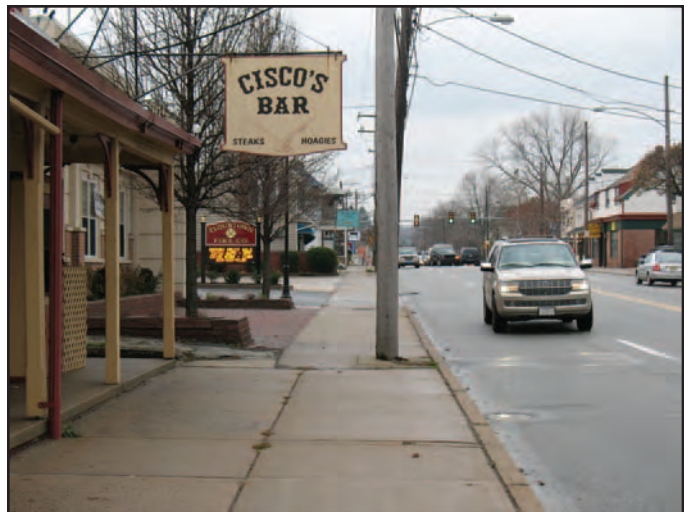
**4. Town center area lacks a distinctive sense of place.**

Between Bysher Avenue and Mill Road, the study corridor contains a significant density of businesses, including many street-edge businesses, with their frontage along Bethlehem Pike. This section also contains several key historic structures. This development pattern creates a foundation for a town-center, main-street type character. However, this business corridor lacks complementary components that accent that character and convey to drivers that the area they are passing through is a special environment, requiring caution and slower speeds. In other communities throughout the region, this "sense of place" has been shown to be important for calming traffic, attracting shoppers, and providing a safe and friendly environment for pedestrians.

A segment of the study area has historic buildings, a critical mass of businesses, and good walkability, but lacks the sense of place that makes other town centers easily identifiable. (Photo: DVRPC)

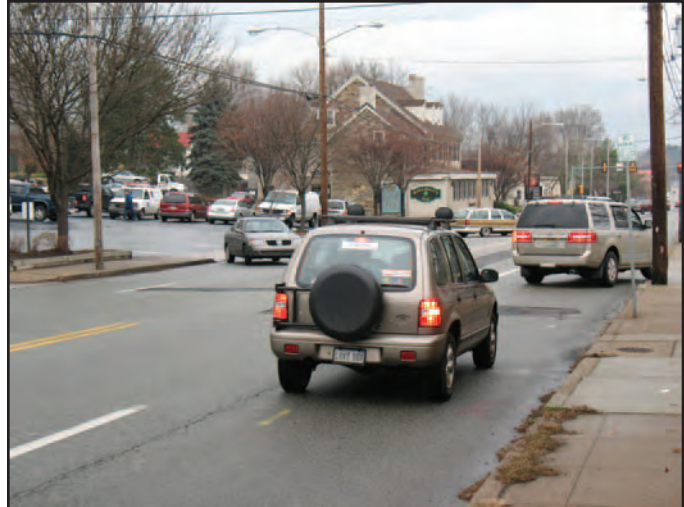
### 5. Conflicts with turning and through traffic at major destinations.

At several points along the corridor, such as the aforementioned Starbucks at Bysher Avenue, there are conflicts between turning and through traffic, resulting in potentially dangerous and difficult driving and pedestrian conditions. Another significant location exhibiting this issue is the corridor section between Mill Road and Weiss Avenue, where there are driveways for the Wawa, Halligan's Pub, and the Acme shopping center. Because these access points are all in close proximity, but are staggered on both sides of the roadway, there is a significant amount of turning traffic from several directions, conflicting with both northbound and southbound through traffic.

The collection of several, staggered access points by the Acme shopping center creates conflicts between turning and through traffic. (Photo: DVRPC)

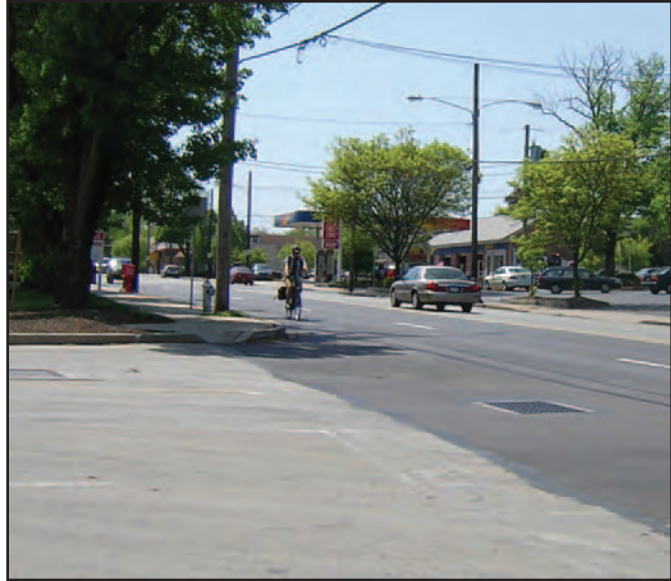
### 7. Corridor lacks adequate bicycle amenities.

As per PennDOT's regulations, bicycles are permitted in the travel lanes of Bethlehem Pike. However, this facility is not very bicycle friendly. Furthermore, the Montgomery County trail system is currently being expanded and will include a trail head, and possibly a trail connection, at Bethlehem Pike, just north of Mill Road. Due to the densely developed residential communities surrounding the corridor, and the forthcoming bicycle traffic due to the trails, it is increasingly important to plan for multi-modal roadway usage, and for this facility to accommodate bicyclists.

The corridor lacks sufficient bicycle amenities, such as "share the road" signs, bike lanes, and storage racks. (Photo: DVRPC)

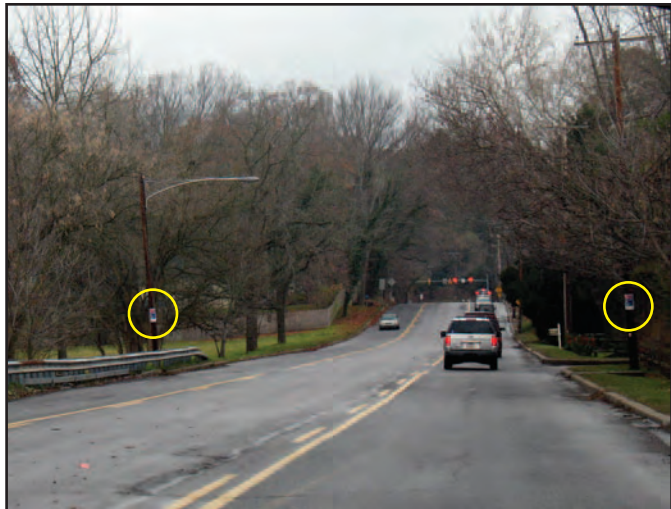
### 8. Lack of accommodations and safety considerations for transit users / minimal presence of transit amenities along the corridor.

The corridor is served by SEPTA's Route L bus. However, most SEPTA stops along the corridor lack basic amenities for transit riders, such as shelters and benches. Some stops are poorly marked and others lack sidewalks or any kind of safe area at which riders can wait. Transit and multi-modal planning are important for supporting the users of alternative modes of travel, and also for calming the behavior of motorists. Drivers tend to proceed more slowly when they share the roadway with other modes of travel, including cyclists, pedestrians, and transit users.

Some areas of the corridor, like this segment just south of Church Road, contain transit stops, but no shelters or safe places to wait. At some points, like the area shown, there are no sidewalks leading to the stops (bus stops are circled in yellow). (Photo: DVRPC)
